## Site 15 - Reesholm

### 15.1 Change of the site by project activities:

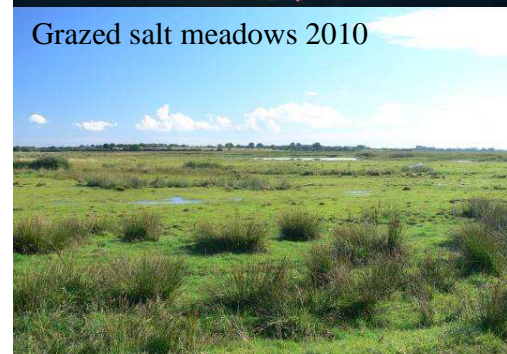
Grazed salt meadows 2010

The fences were removed in the north to allow better accessibility for the cattle to the central plots. This was quite successful and the grazing of the reed beds on overgrown salt meadows showing positive effects.

By the grazing regime the spring/ summer grazing in the salt meadows is combined with autumn/ winter grazing both on salt meadows and on the drier parts on the former island of Reesholm. By this regime mat grassland on the former island had been developed into a good conservation status. The grazing of reed beds was improved by a new cattle bridge build in 2010.

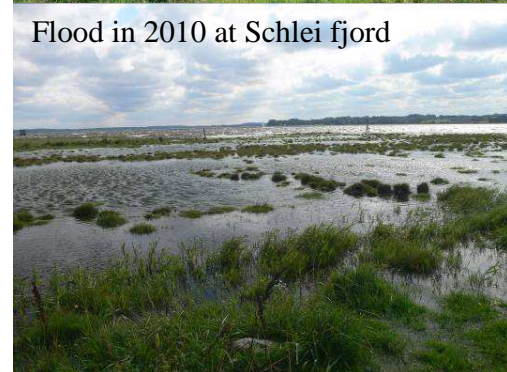
Flood in 2010 at Schlei fjord

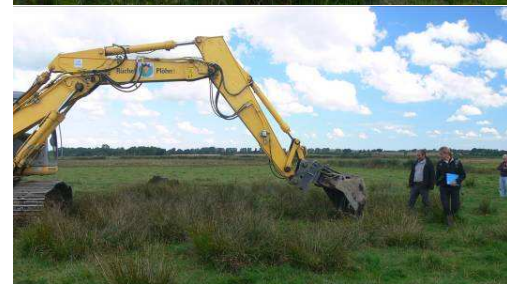
Test holes for restoration of depressions

In 2010 ditches were blocked successfully. By that action one lagoon was reactivated in the south of the peninsula. The material for the ditch blockings was taken from the natural depressions which were improved to retain more fresh water in the upper salt meadow.
