## Site 13: Ulvshale

### 13.1 Change of the site by project activities:

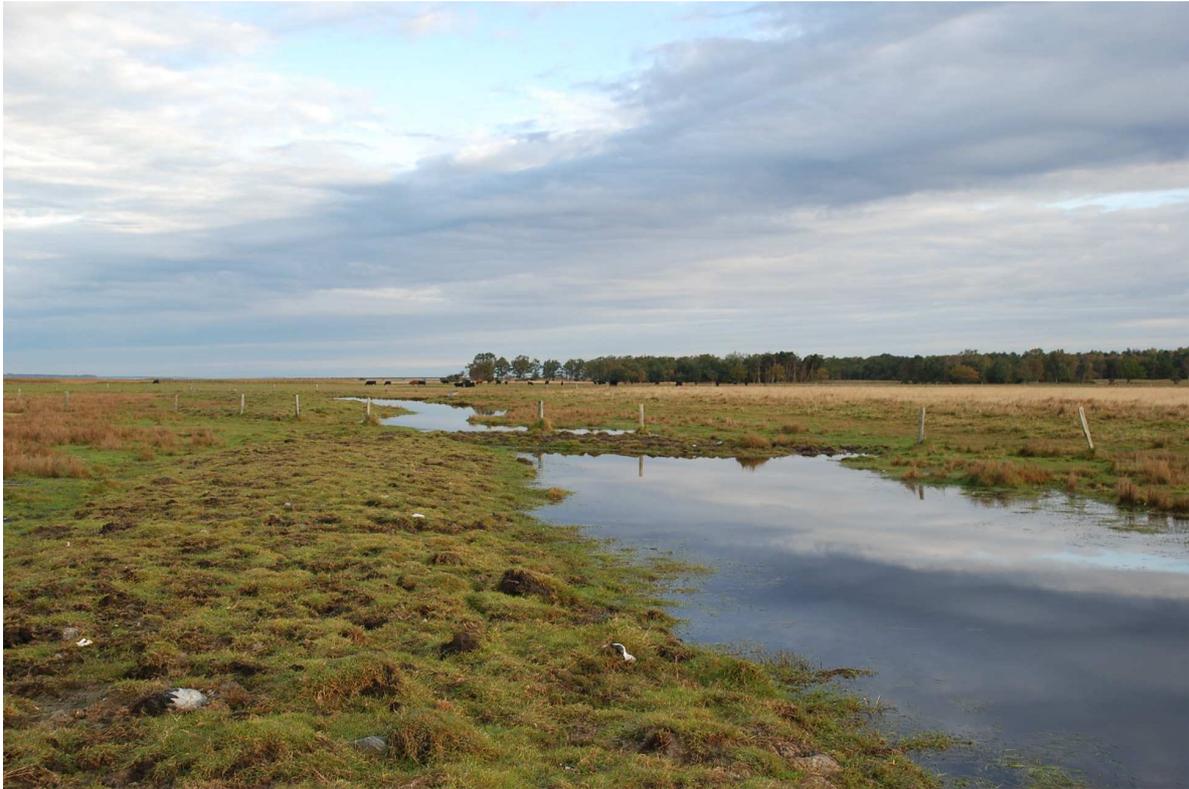
*The only water body with clay bottom. Photo Kåre Fog*

Most water bodies are placed on coarse sandy bottom, and they are filled with salty ground water. Only one water body could be made with clay bottom, and the water here is slightly more fresh (c. 6 per mille).

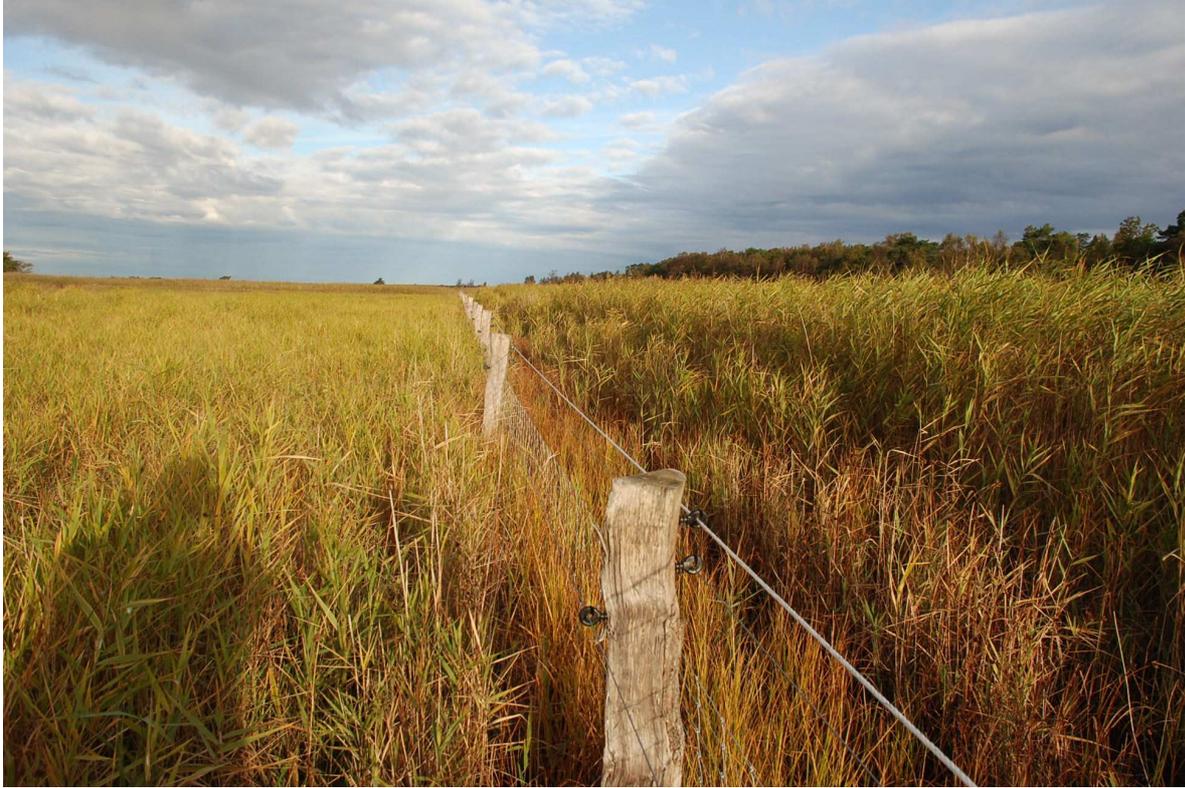
*The fox fence. Photo Kåre Fog*

At Horsnæs, the grazing pressure and the area grazed has gradually increased during the project period. In the most important areas, all trees and bushes have been cut in order to reduce predation from crows that perch in the tree tops. The cattle fence has been placed as close as possible to the shore, but only in very few places is it possible to extend the grazing right to the seashore. In 2009, two major changes were made: 1) many water bodies – small and somewhat larger – were excavated to create more permanent water bodies. 2) The whole area was surrounded by a 'fox fence' in the hope to keep out foxes.

In 2011, the fox fence was improved in various ways. Gates for pedestrians were made higher so that foxes cannot jump over them. At the north and south end of the fence, the part extending into the sea was replaced by the same system of tall sloping metal fence that has been set up at Hyllekrog (project site no. 14).

The fox fence still needs to be improved in certain small details.
